Elderly and people with disabilities - Limitations in their everyday life

Three case studies

Three case studies with elderly people and people with disabilities in different situations are presented as examples of adaptation of the bathroom area. Concrete solutions that have been found with respect to their limitations and the way they successfully solved their problems by means of home adaptations using either low-tech solutions or high tech devices are described.

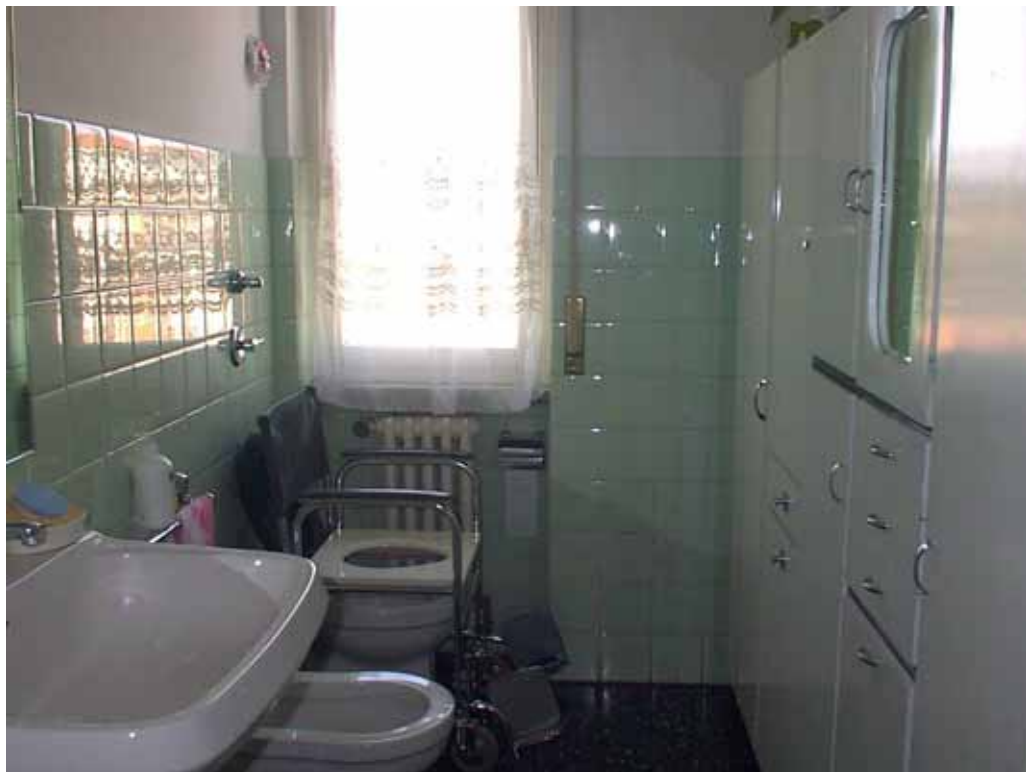
Luigi's bathroom

Luigi moves independently inside his home. He uses a walker to support shifting. When he arrives in front of the bathroom door, he leaves the walker outside and uses different support points (the door handle, the wash machine, the sink, the drawer handle), until he arrives in position to seat on the toilet bowl.

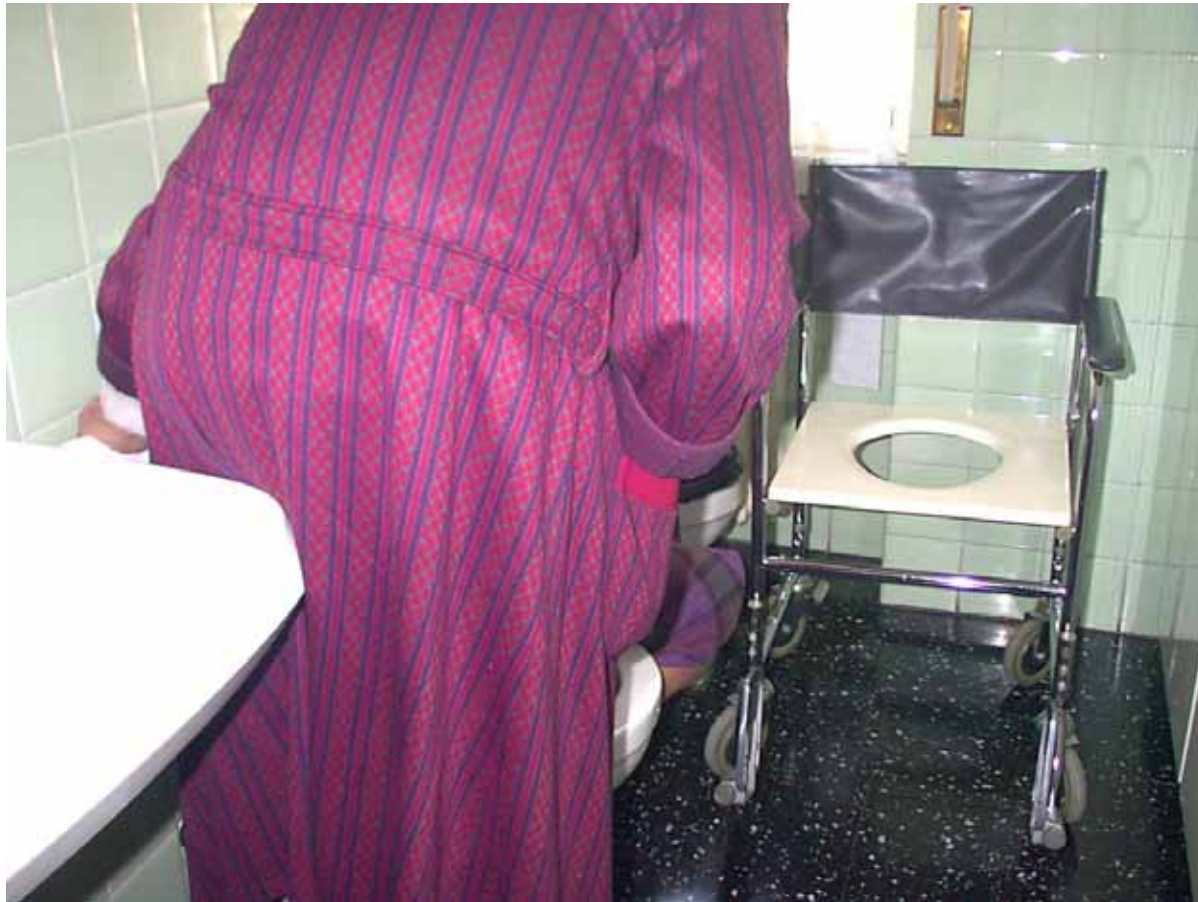
How Luigi moves inside of his bathroom

- Luigi moves slowly and needs to lean against the sink, the support bars, and handles.
- The comoda chair has a hard surface causes pain to seat down

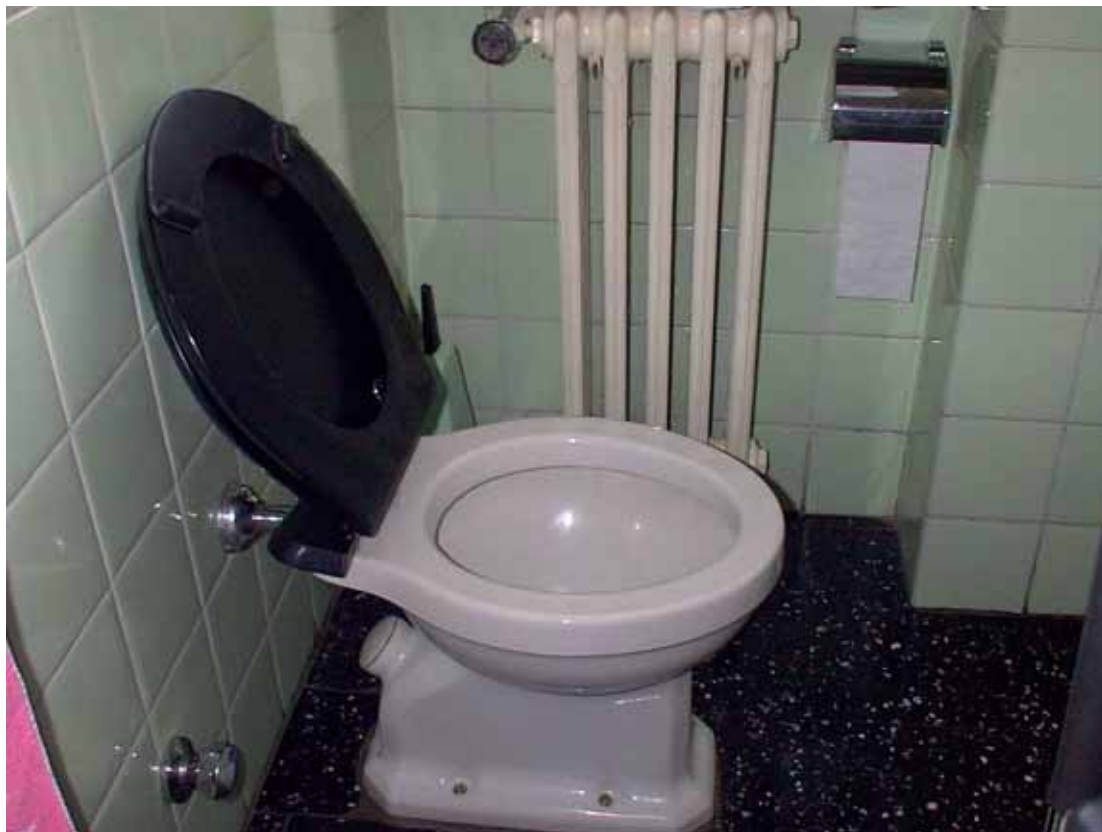
The toilet bowl

- The height of toilet seating is lower than a standard; it is only 42 cm. including the toilet seat. As the problems related to growing old, includes sitting down and getting up of the toilet increase, Luigi becomes dependent on his wife

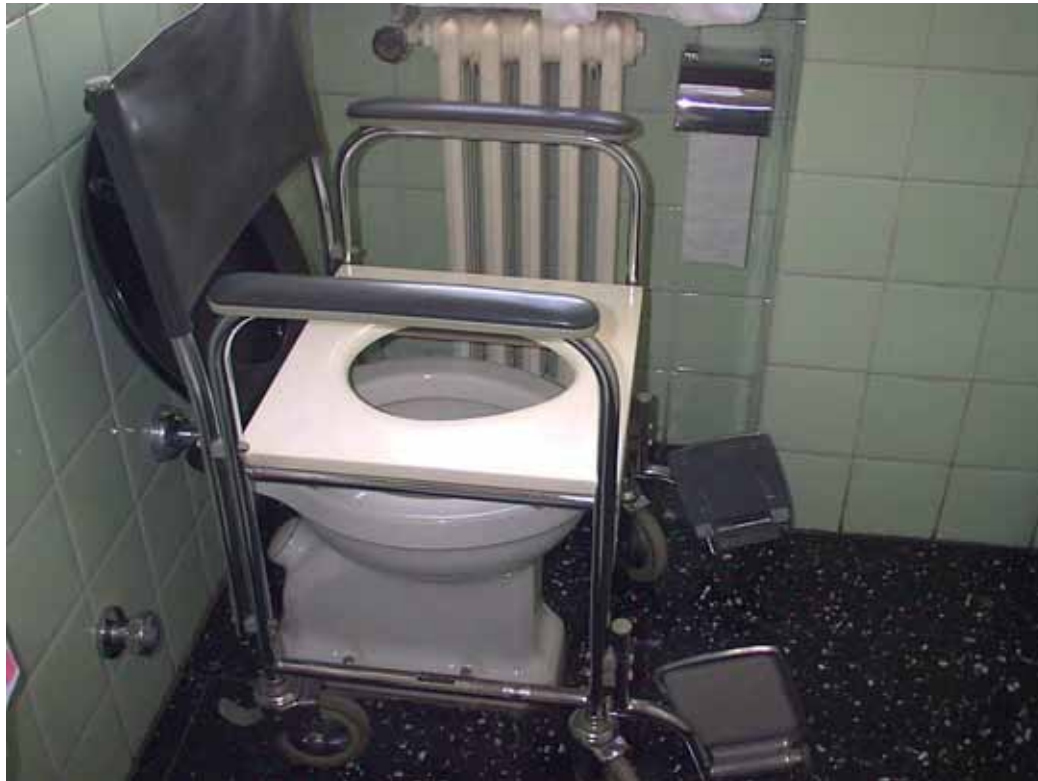
Toilet bowl with comoda chair

With increasing of difficulties, Luigi used a comoda chair to be indepent but actually the hard surface generates pain and leads also to skin problems

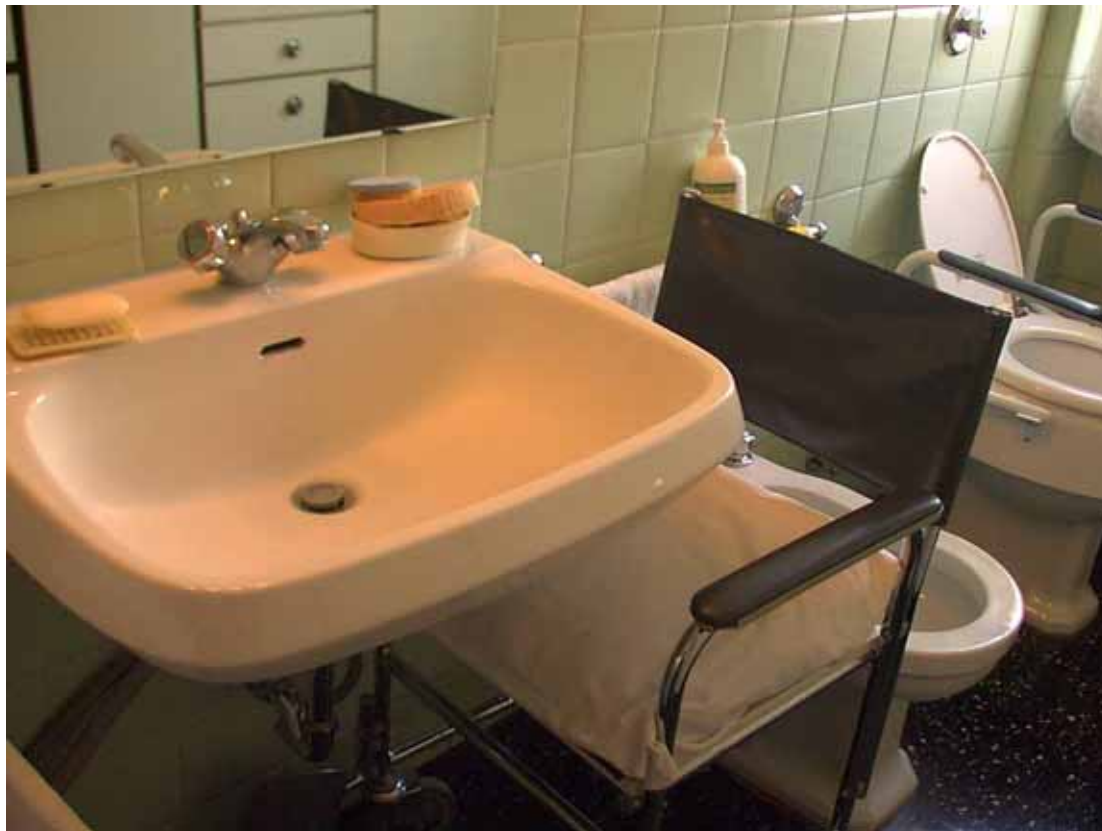
The way Luigi uses the sink

- The sink: By using a commode chair placed near the sink, , equipped with a cushion, because the hard surface generates pain and leads also to skin problems in the sciatic region just where there is the point of support when he is sitting Luigi seats down to execute the daily morning activities of personal hygiene; he washes his face, brushes his teeth, combs his hair and shaves without help.

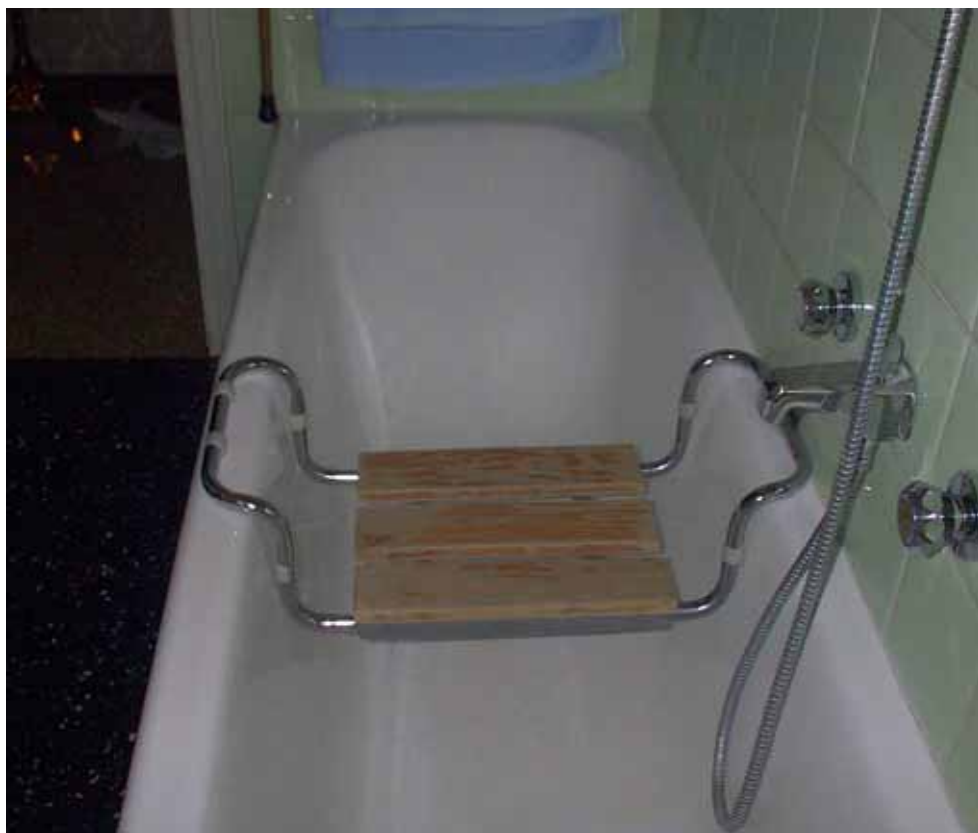
The wash tub

- Luigi has slowness in movement, he tries hard to get up from seating, he feels back pain and has also edema in the legs.
- He was not able any more to go in and out of wash tub

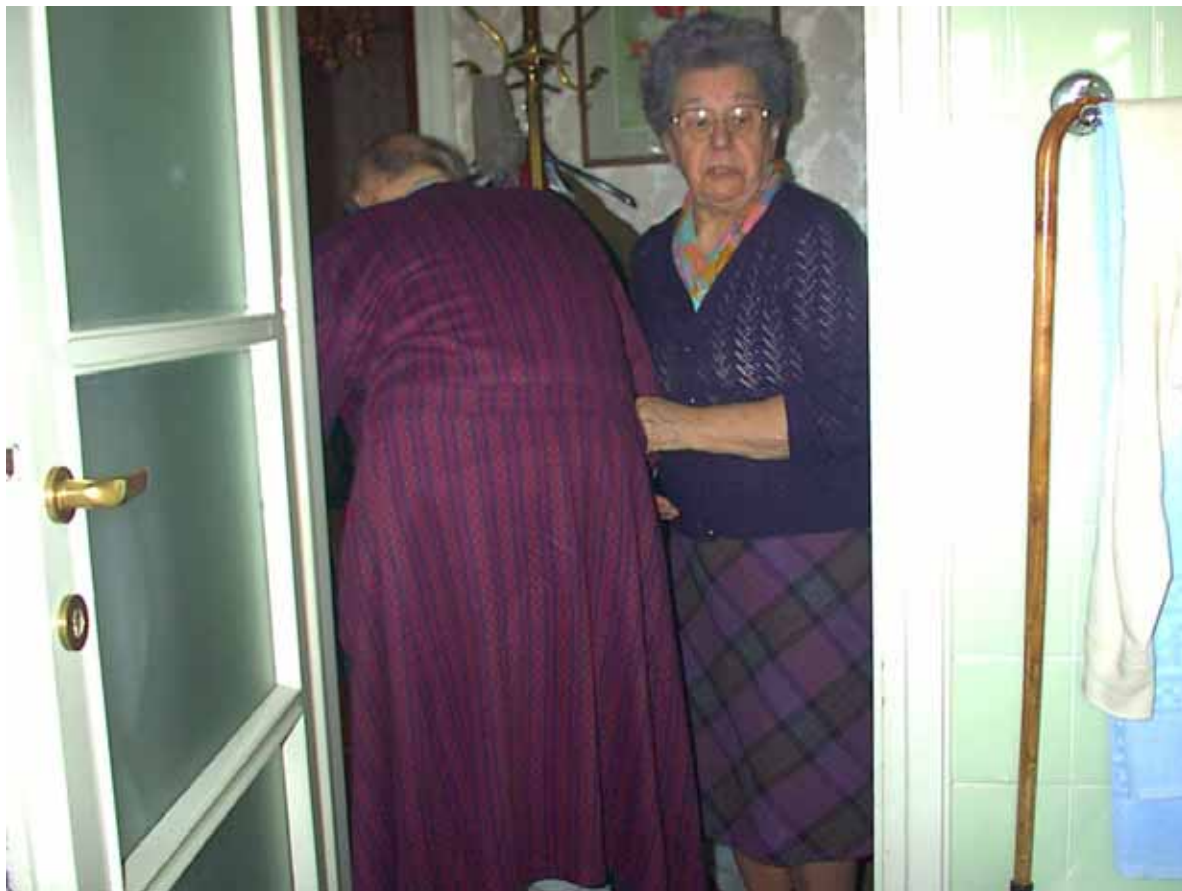
Luigi and his wife going out of bathroom

- Luigi uses a stick and handles to move inside of his bathroom and leave it before go out
- Her wife helps him reach the walker

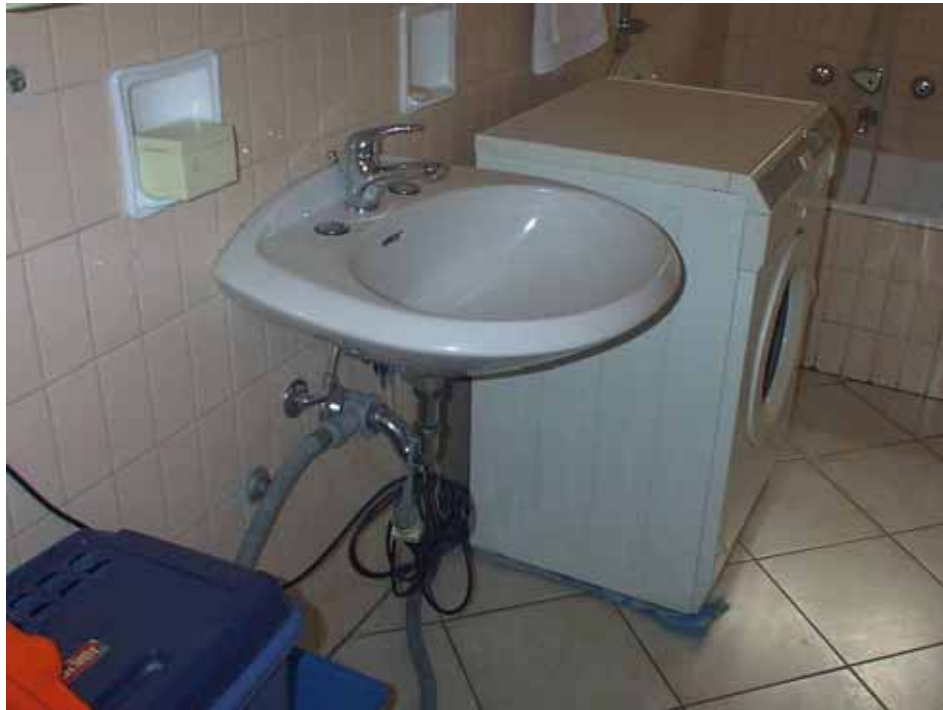
The main bathroom

- It is the spaciously but the wash tub was not indicate to give Silvia's more autonomy

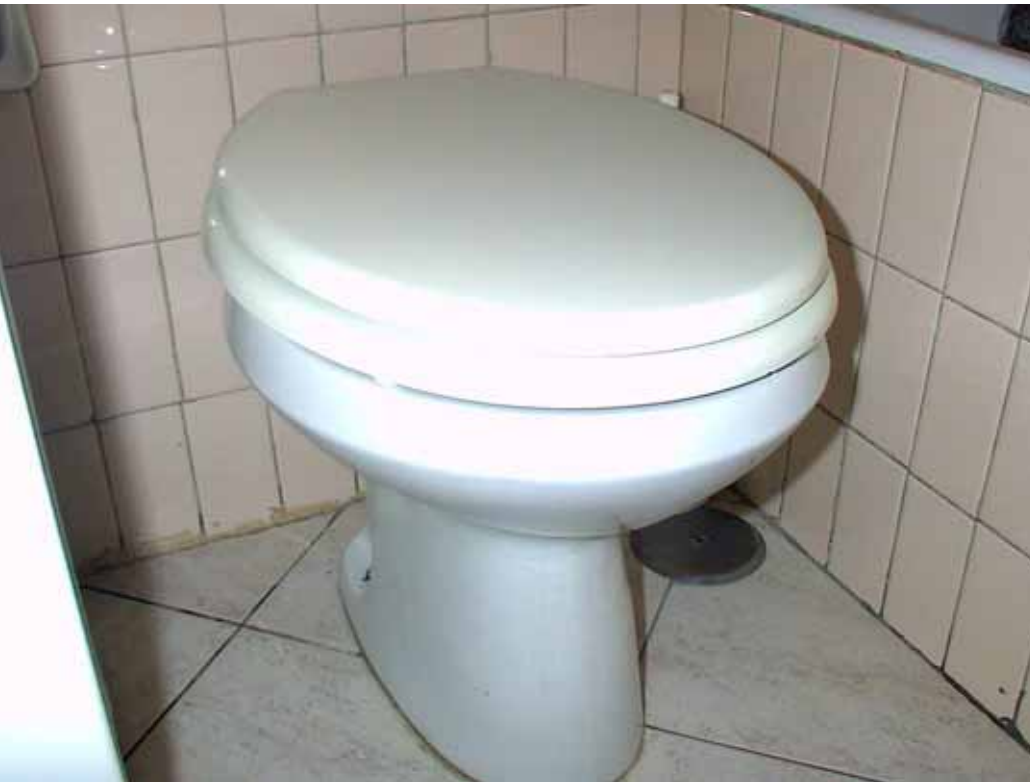
The toilet bowl

- The height of toilet seating is lower than a standard; it is only 42 cm. including the toilet seat.
- It is placed against the wash tub and it is no place to transfer

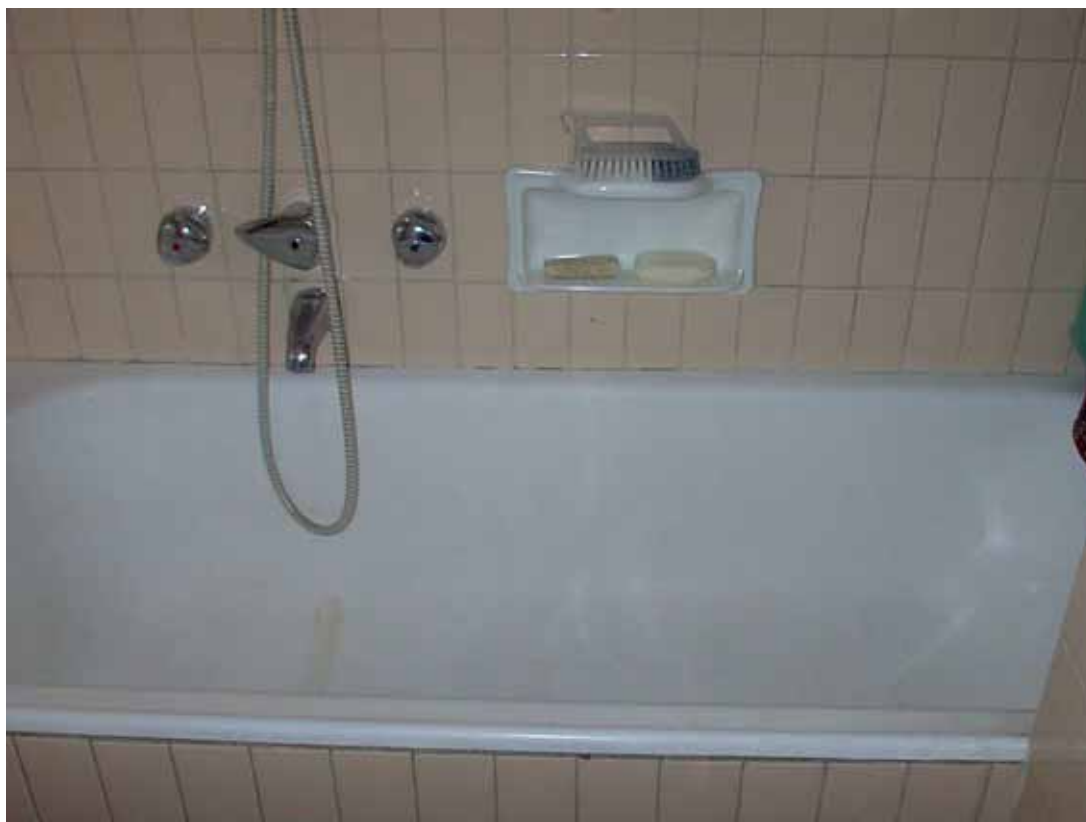
The wash tub

- The access in the wash tub is difficult. Silvia can arrive only by the front side.

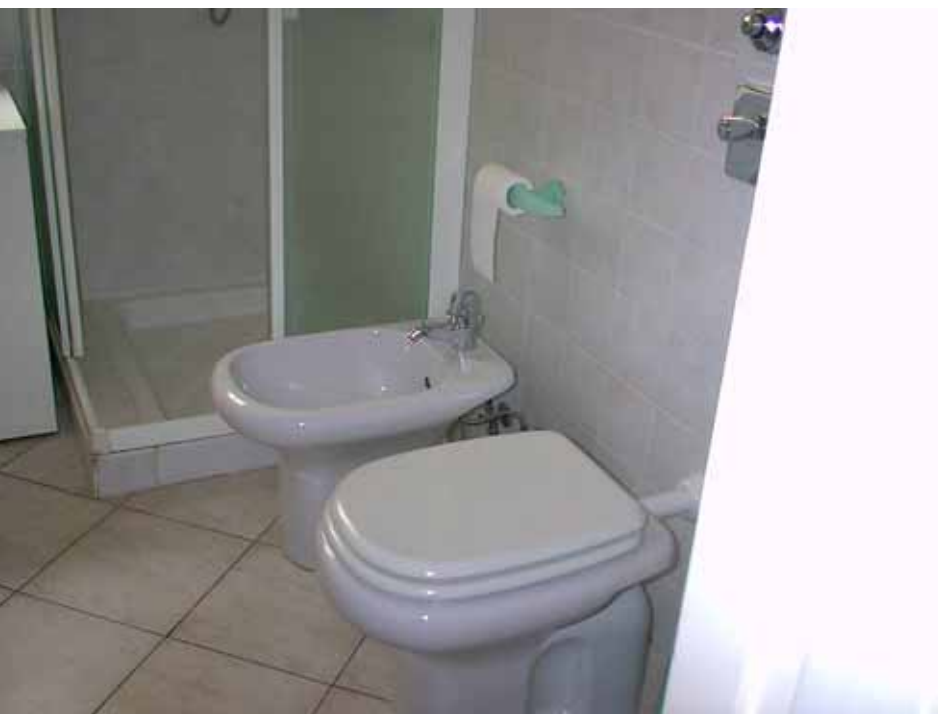
The small bathroom

- The box shower is not accessible (there is a degree high 13 cm.)
- The bidet hinder the the pass

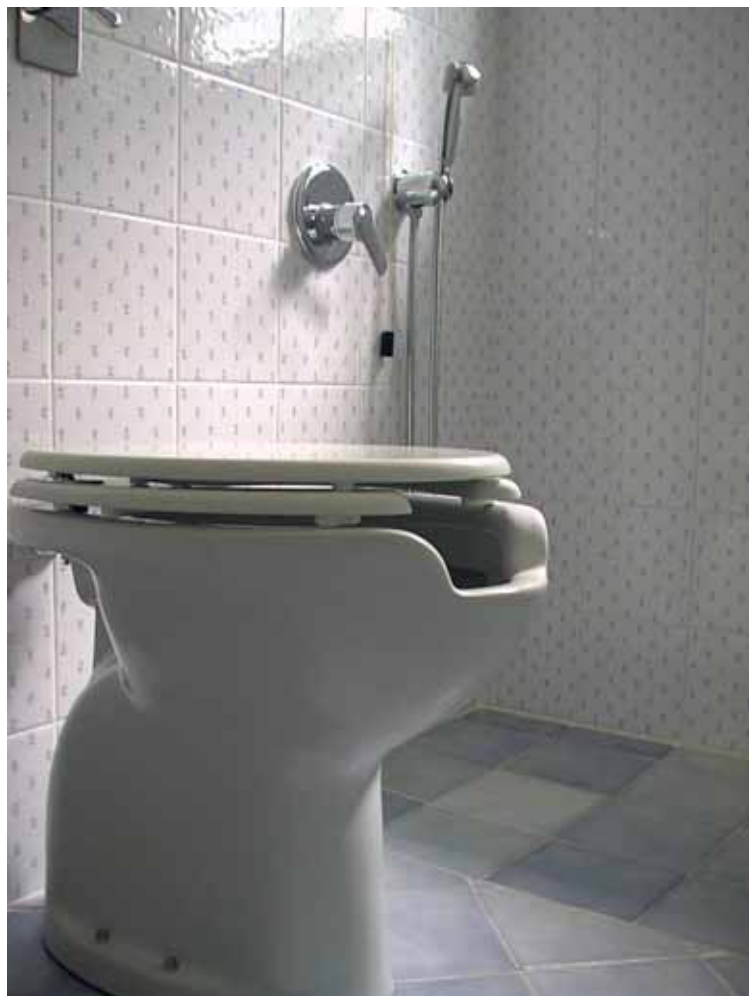
The toilet bowl

- The toilet bowl: The bowl has a double function; as a WC and as a bidet. It is about 50 cm. high and it is provided with a front opening in order to allow the washing operations through the use of an external shower

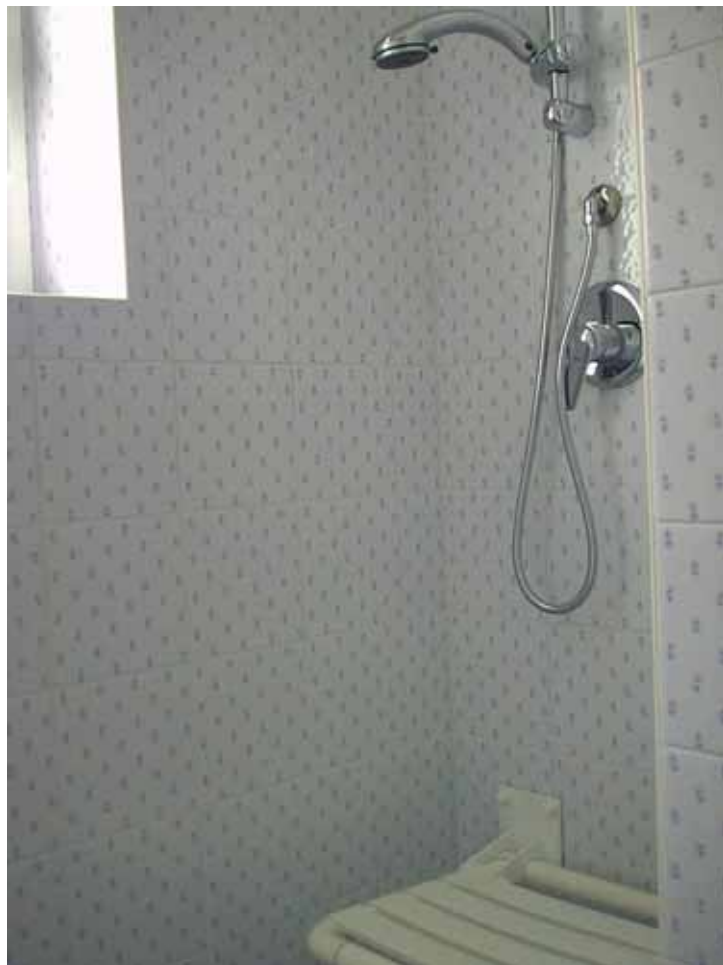
The box shower

- The box shower: A shower tray floor edge and a folding seat
- Silvia can use the shower chair from bedroom

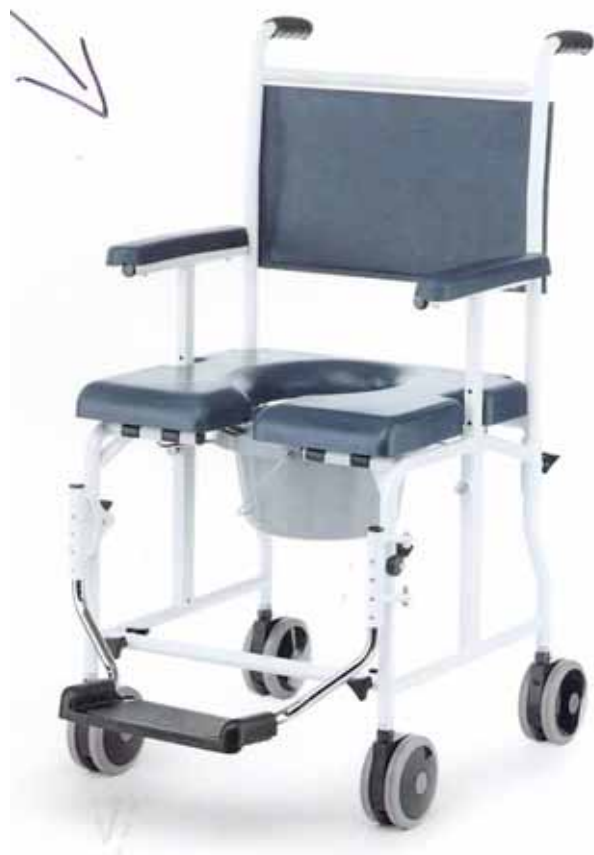
The shower chair

- Silvia transfer from wheelchair to shower chair and reach shower box push by an assistant

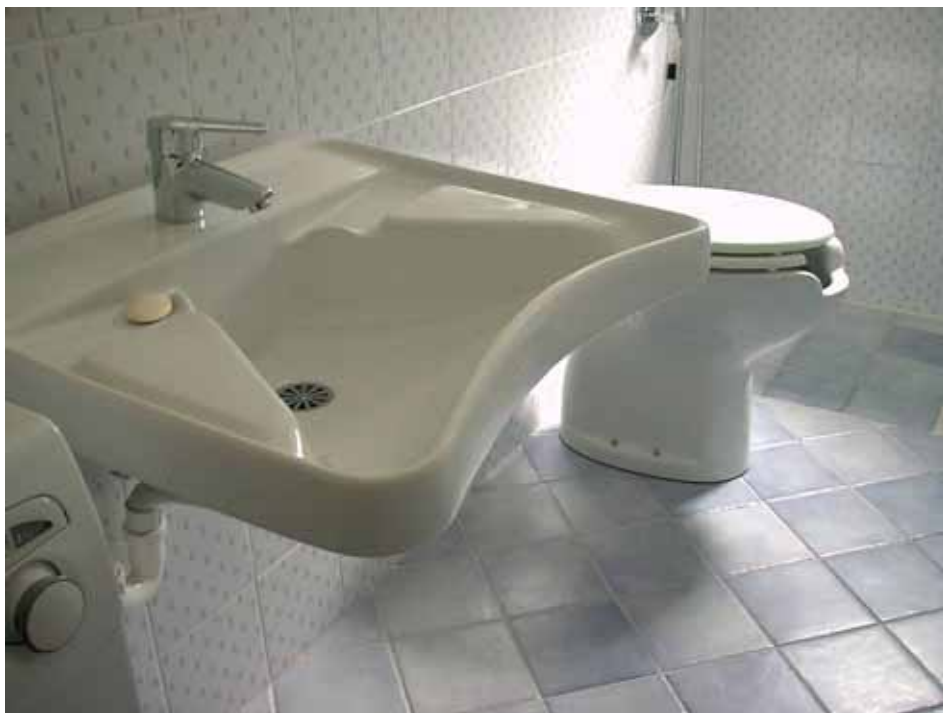
The wash basin

- The washbasin: Baked clay washbasin is provide with rest for the elbows, splashboard borders and it has a particular hollow shape which allows an easier access

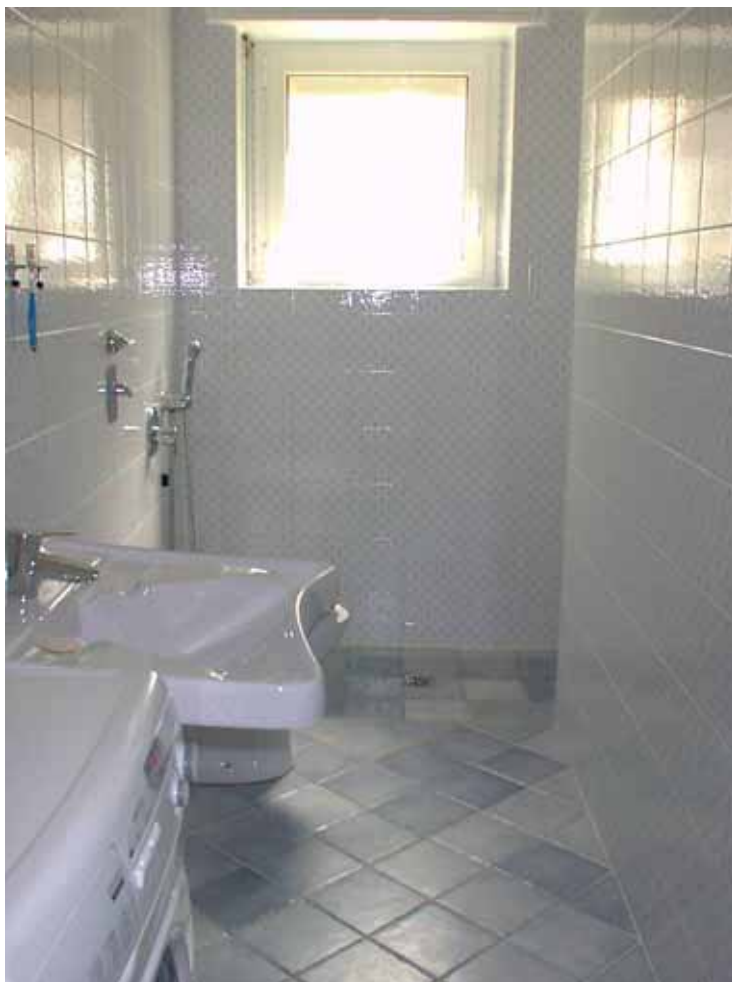
The new bathroom

- The room is spacious to move inside by a wheelchair user and an assistant. Silvia now is able to use the new bathroom more safely and comfortably.

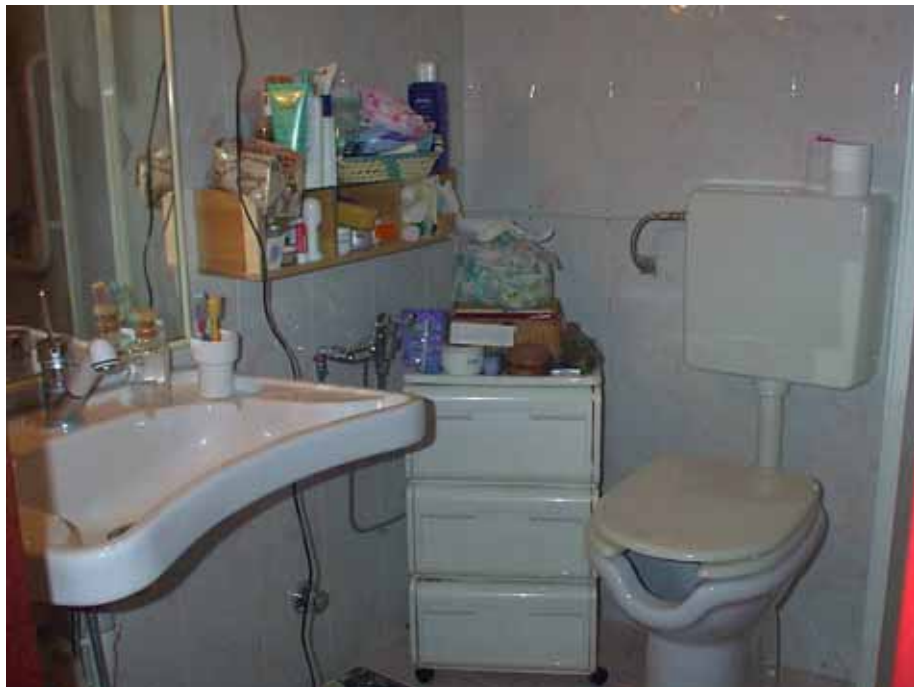
The accessibility and to toilet bowl

- The access is impaired on the left side by the sink and on the right side by the shower box. There is no place to install support to the transfers and it is too high for the user. The height of WC should be the same as the wheelchair (it is too high).

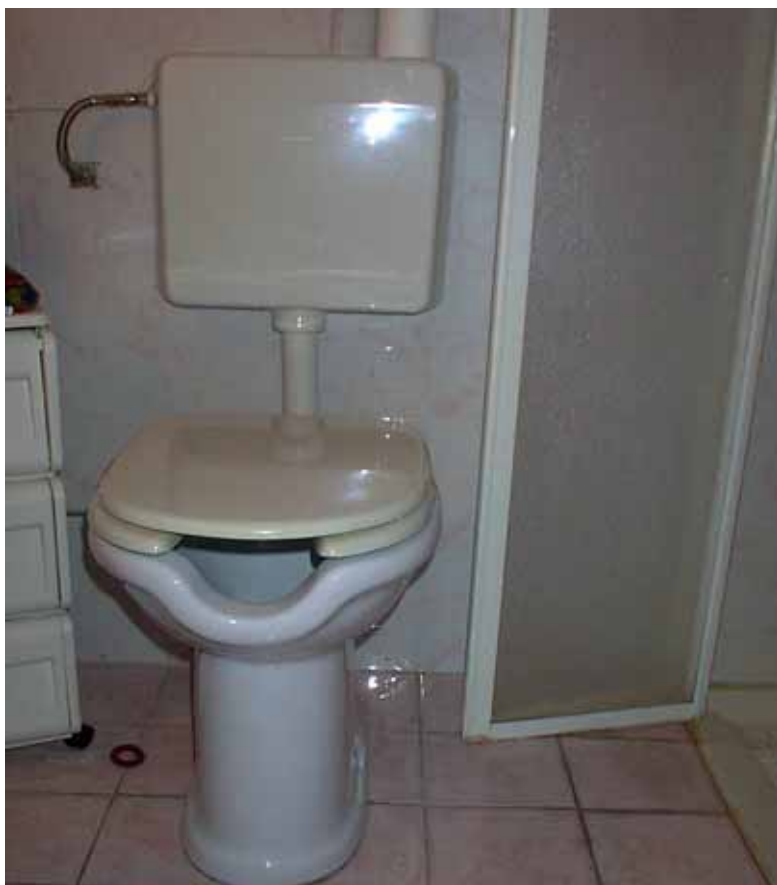
The toilet bowl

- The bowl has an opening at the front side, designed to help with cleaning, however, it creates instability. Tina has spastic legs and the transfer can produce contractions and she does not feel safe; she fears the empty space in front of her while attempting transfer.

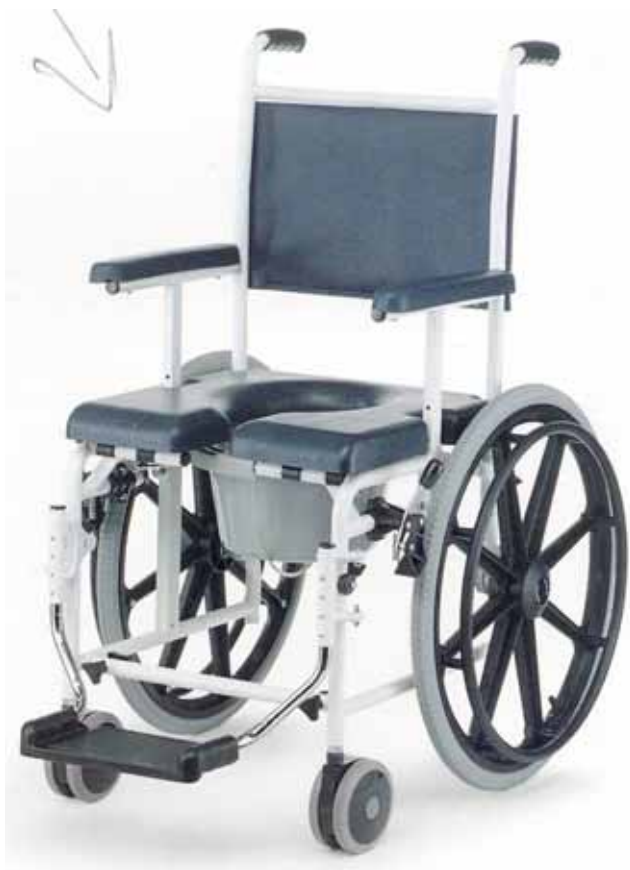
The shower chair with big wheels

By this way,
the transfer will be done in
the
bedroom (bed to shower chair
and
shower chair to bed).

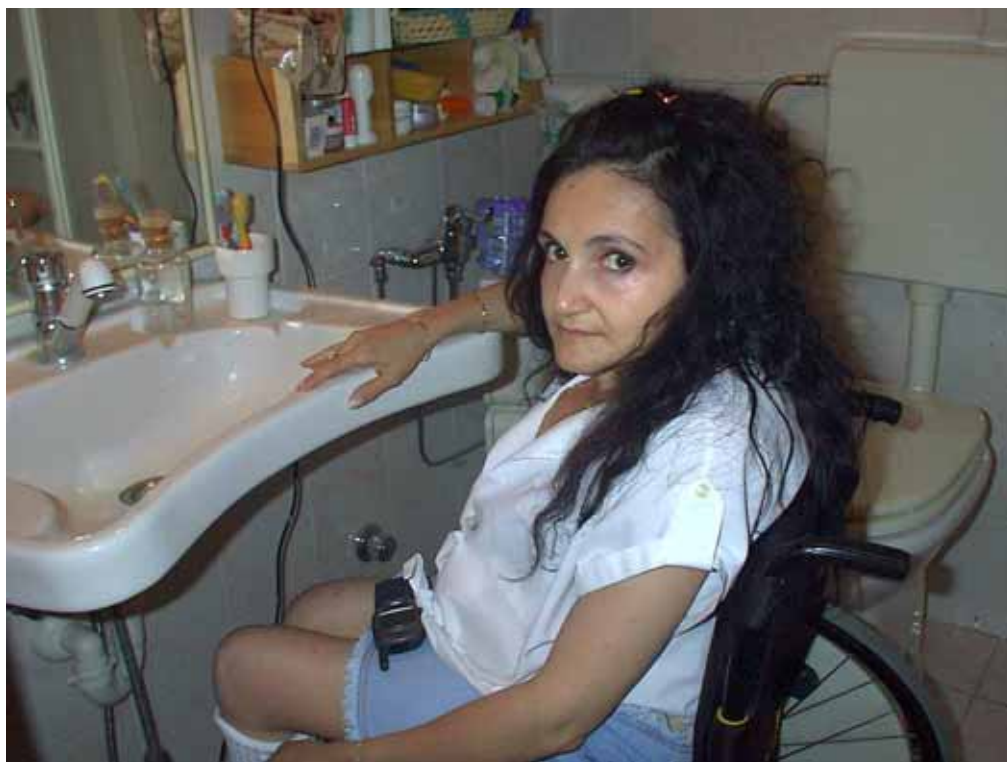
The Sink:

The accessibility, the size, and height are considered by Tina adequate. The mixer tap is easy to handle and safe.

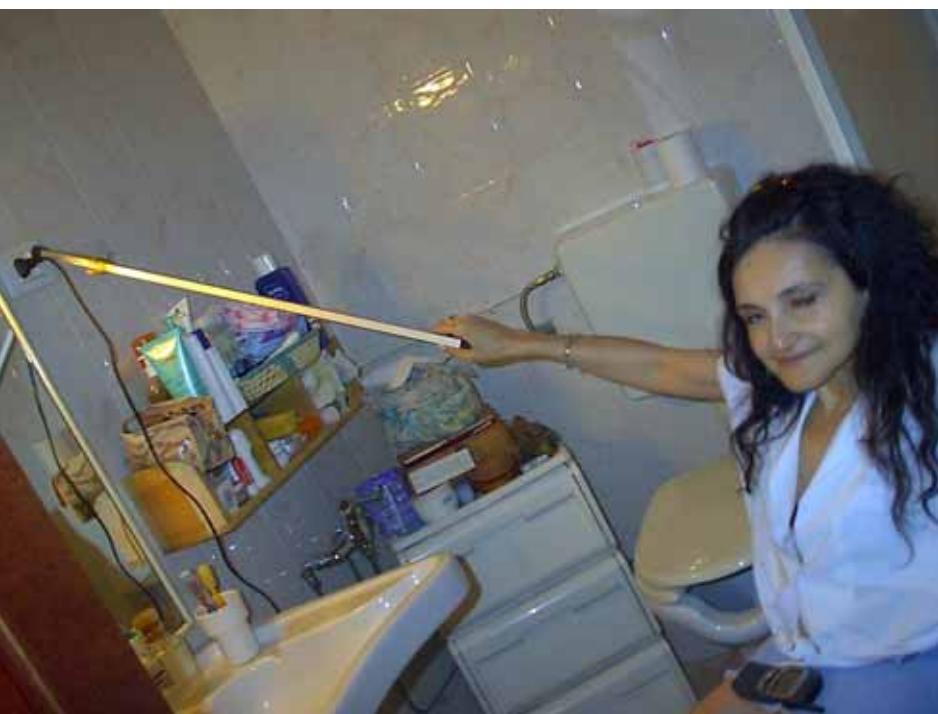
The light point and electrical outlet:

- It is located too high (150 cm) and it is not accessible. To turn on the light she uses a walking stick but the electrical outlet is not usable.

Transfer the light point and electrical outlet at 100 cm high and at the left side of the sink because access is easier
Tina is satisfy of illumination of her bathroom
